Portage Creek Sediment Remediation Project Kalamazoo, Michigan

Pre-Sediment Removal Structure Feature Assessment
Removal Areas SA1-A, SA1-B and SA1-C

F&V Project Number: 809930
May, 2013

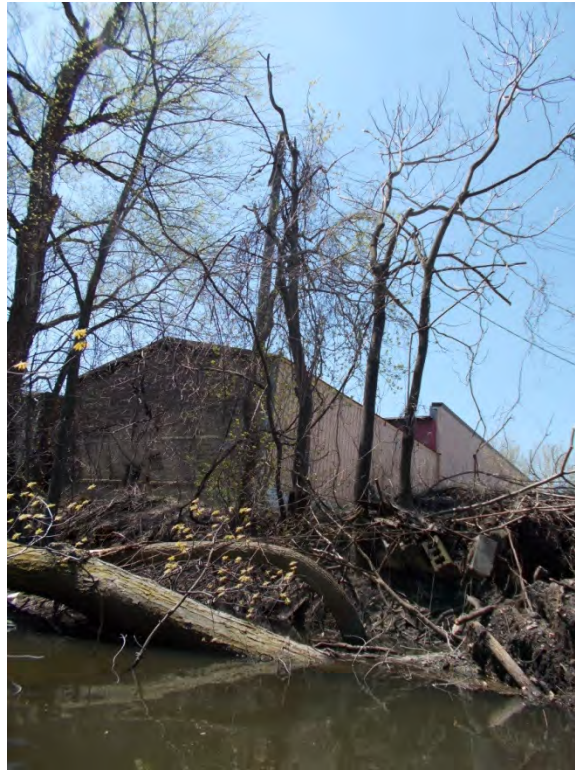
- A large tree recently fell along the west bank of Portage Creek. The guy wire for the pole appears to be tangled with the tree, which is now located across the creek.
- The pole itself is severely weathered and has splitting throughout its length.

Pole viewed from the channel

- The utility company should be notified of the impacted guy wire, so that repairs can be made to stabilize the pole prior to sediment removal operations.
- Sediment should not be removed within the 1:1 influence area of the pole or guy anchor unless the pole is supported during the work.
- Construction fencing or similar means should be used to identify the pole and guy to operators and drivers during the work.

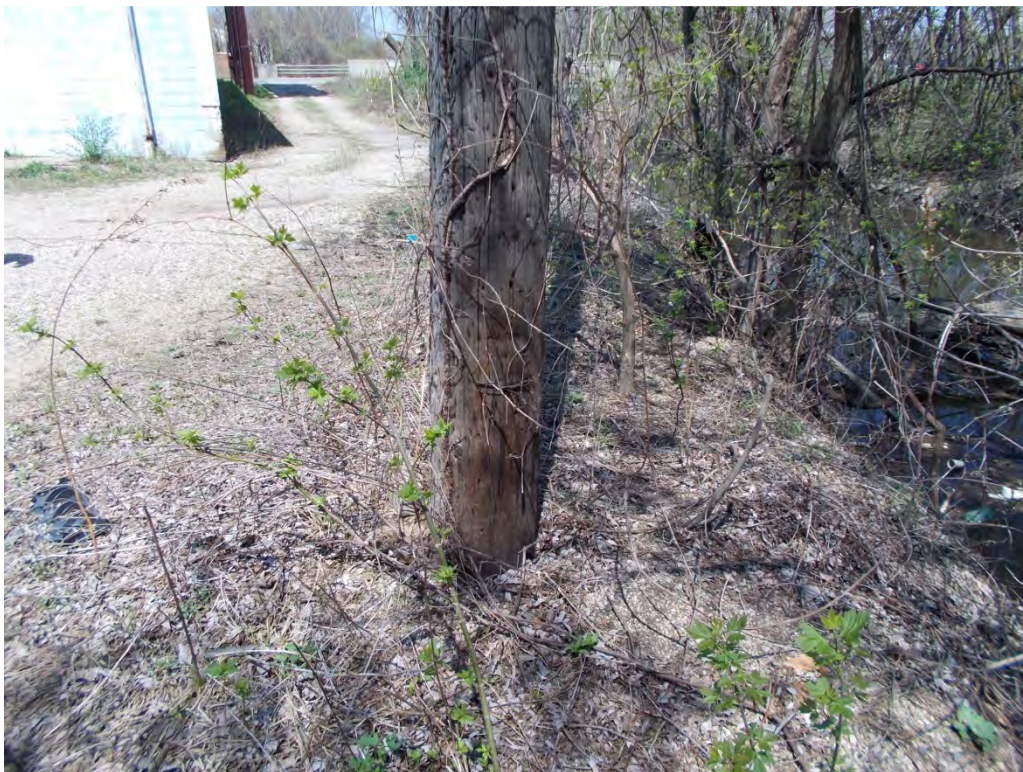
Weathering and splitting on the pole above grade

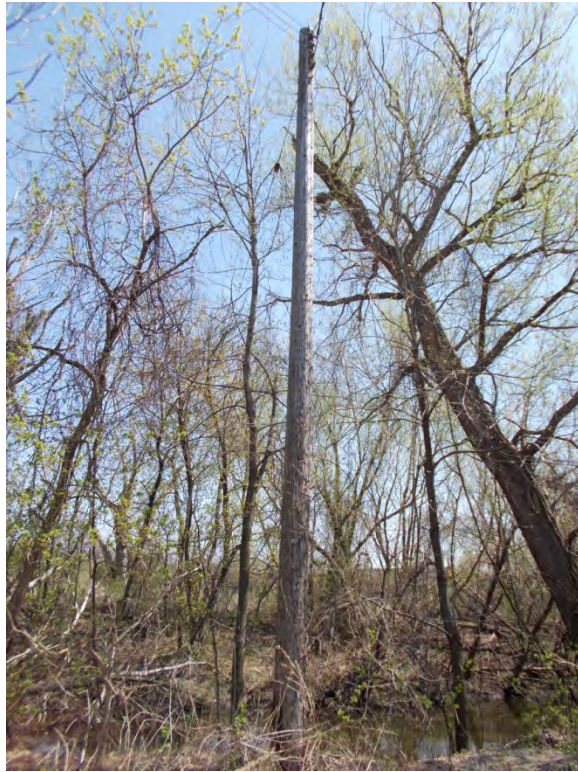
View of the pole and tangle guy looking east

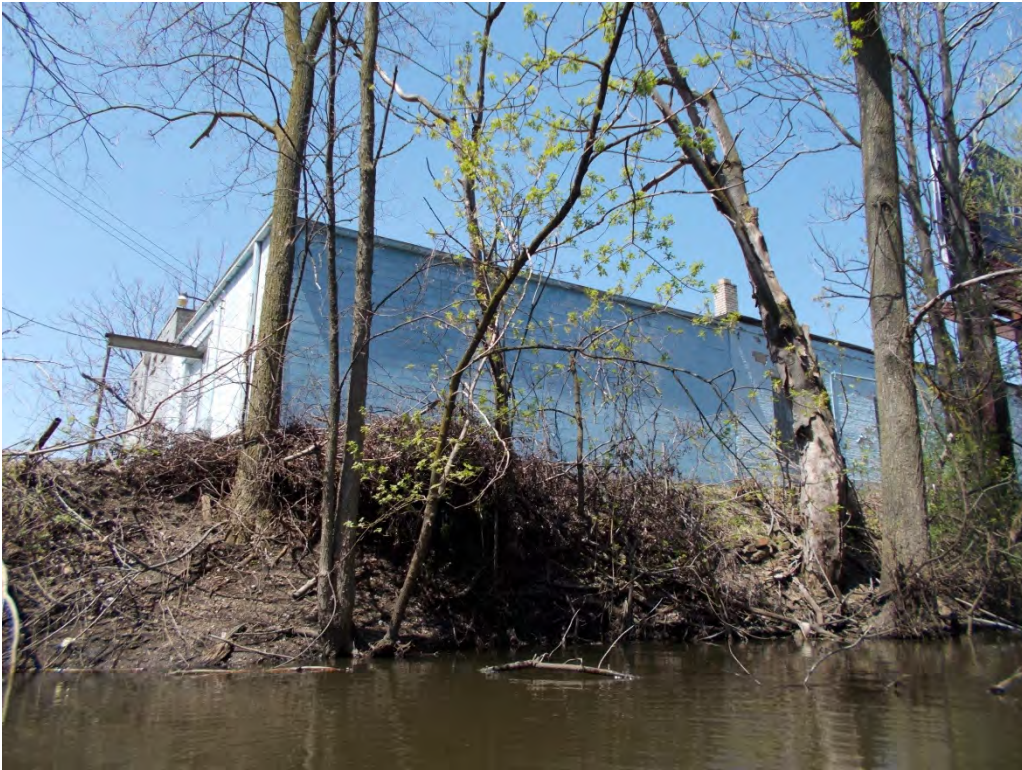
- The CMU has moderate vertical and step cracking.
- A severe vertical crack was noted at the joint between sections of the building.

View of the south portion of the structure from the channel

- The building appears to be outside the influence of the sediment removal. Operators and drivers should use due care when working around the building to avoid damage from equipment.

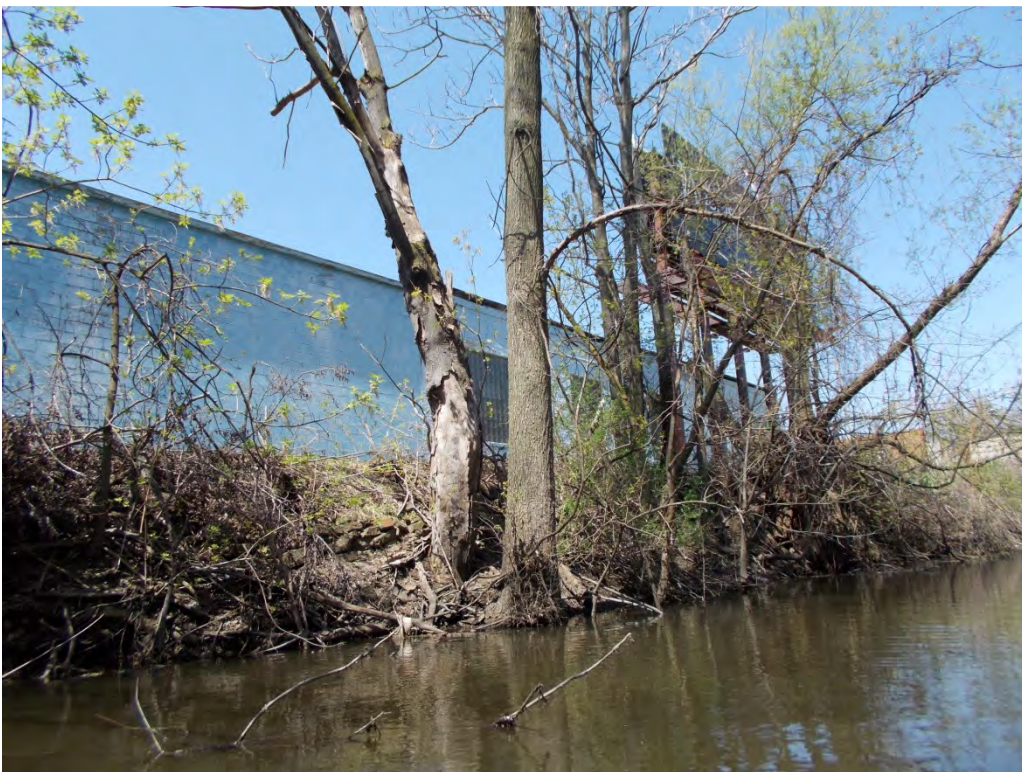
View of the north portion of the structure from the channel

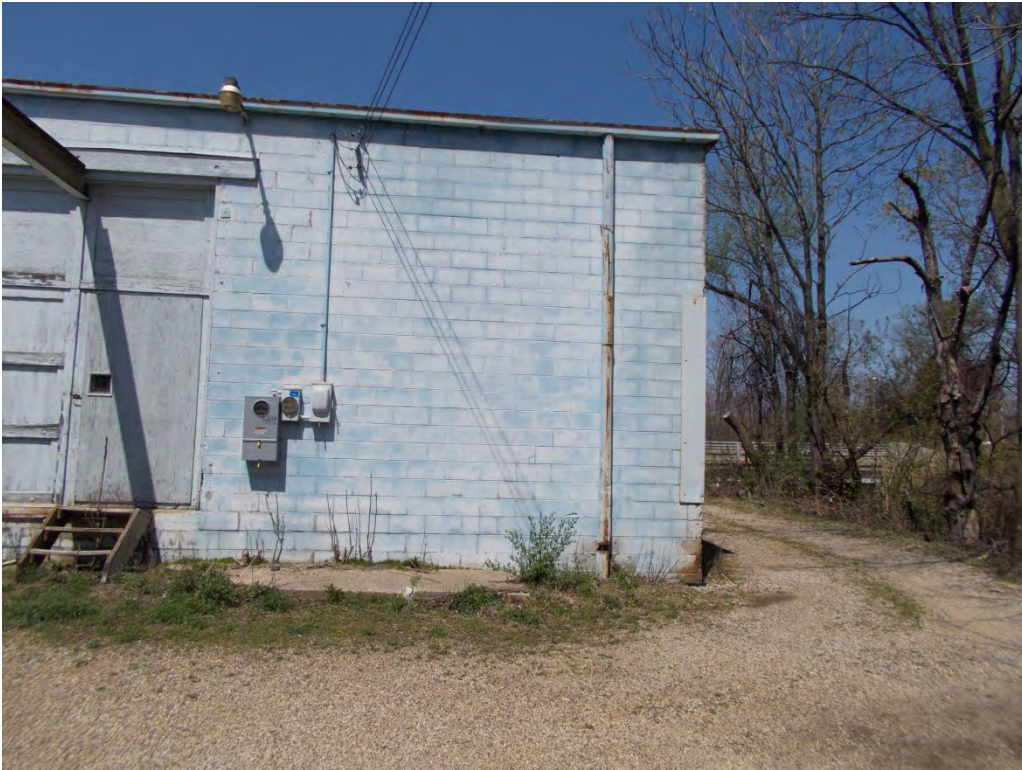
View of the southeast corner of the structure looking north

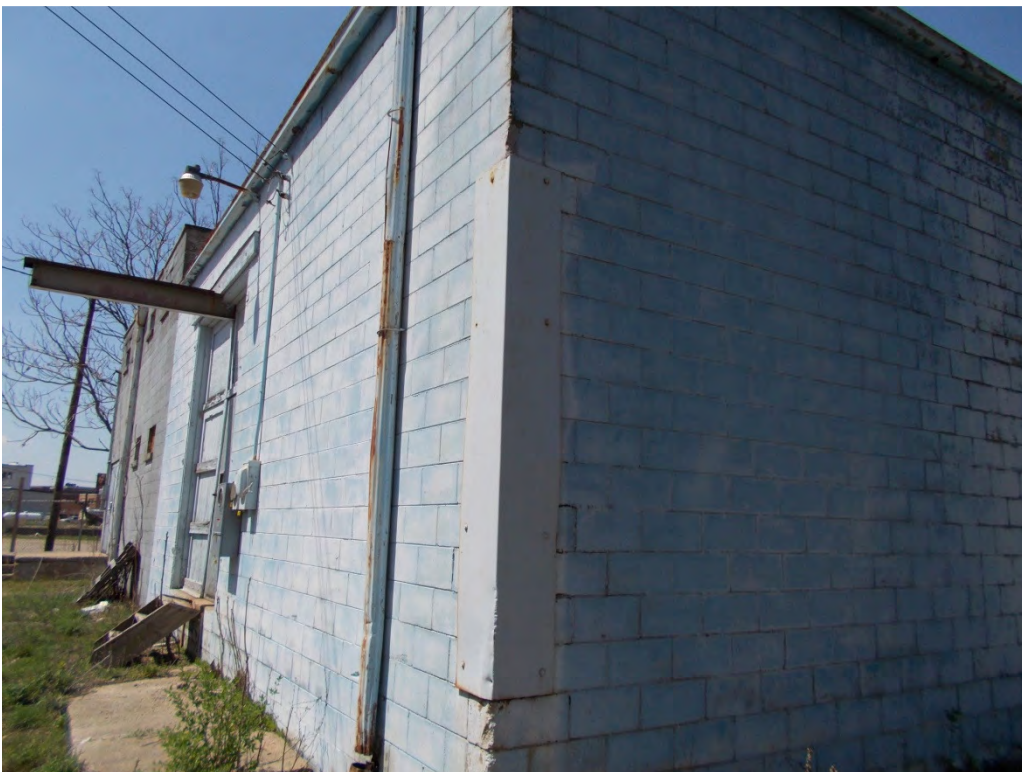
Steel reinforcing angle on the southeast corner of the building

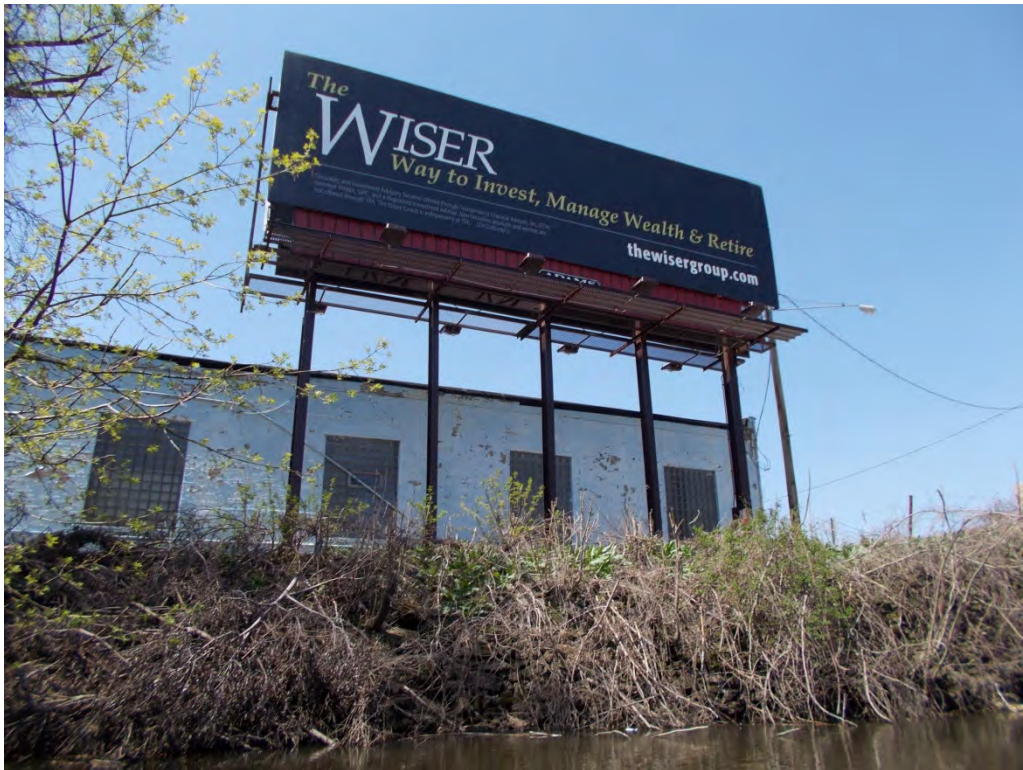
- The steel columns appear to be in fair to good condition, with paint mostly intact. The columns extend below grade to a suspected deep foundation.
- The billboard itself and other ancillary portions of the structure appear to be in good condition as well.

View of the structure from the channel

- Because it is suspected that the structure is supported on a deep foundation, it is likely outside the influence of the sediment removal.
- Construction fencing or similar means should be used to identify the columns to operators and drivers during the work.

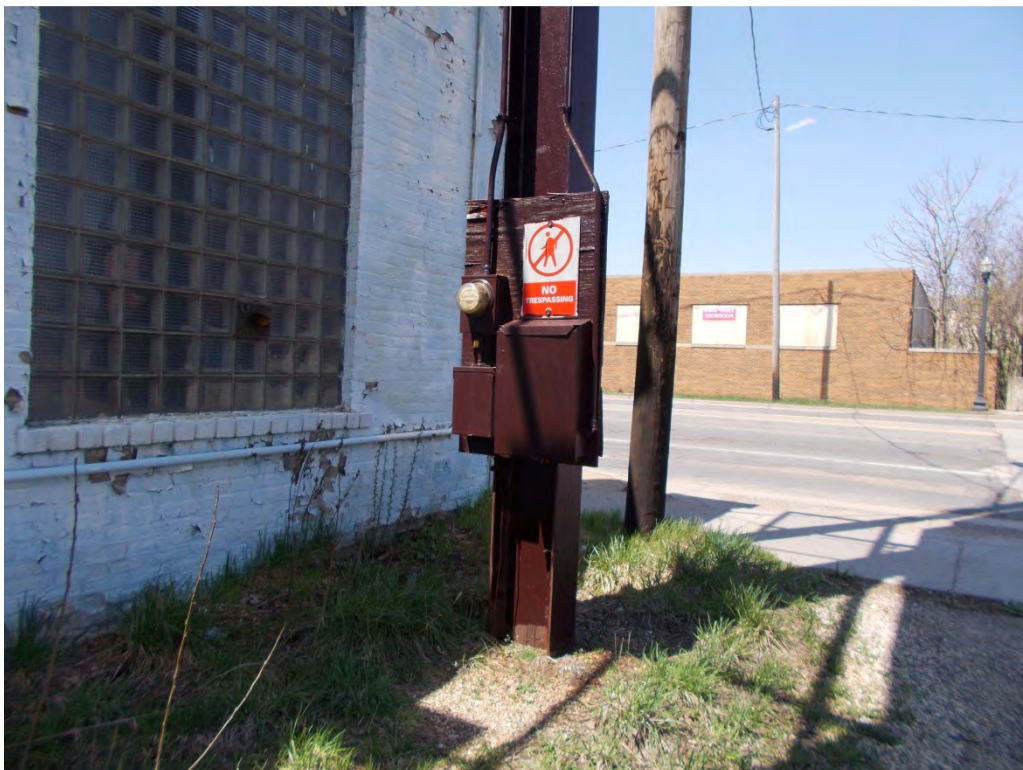
Electric service panel mounted to northernmost column

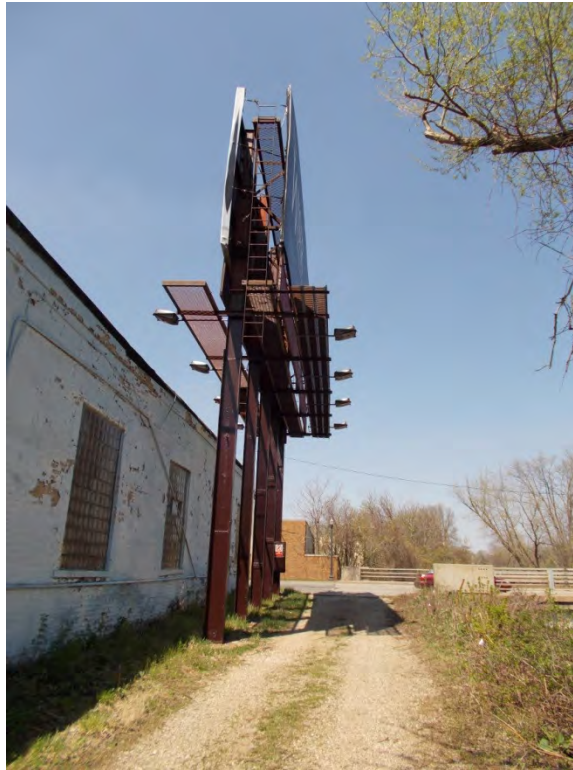
View of the structure looking north

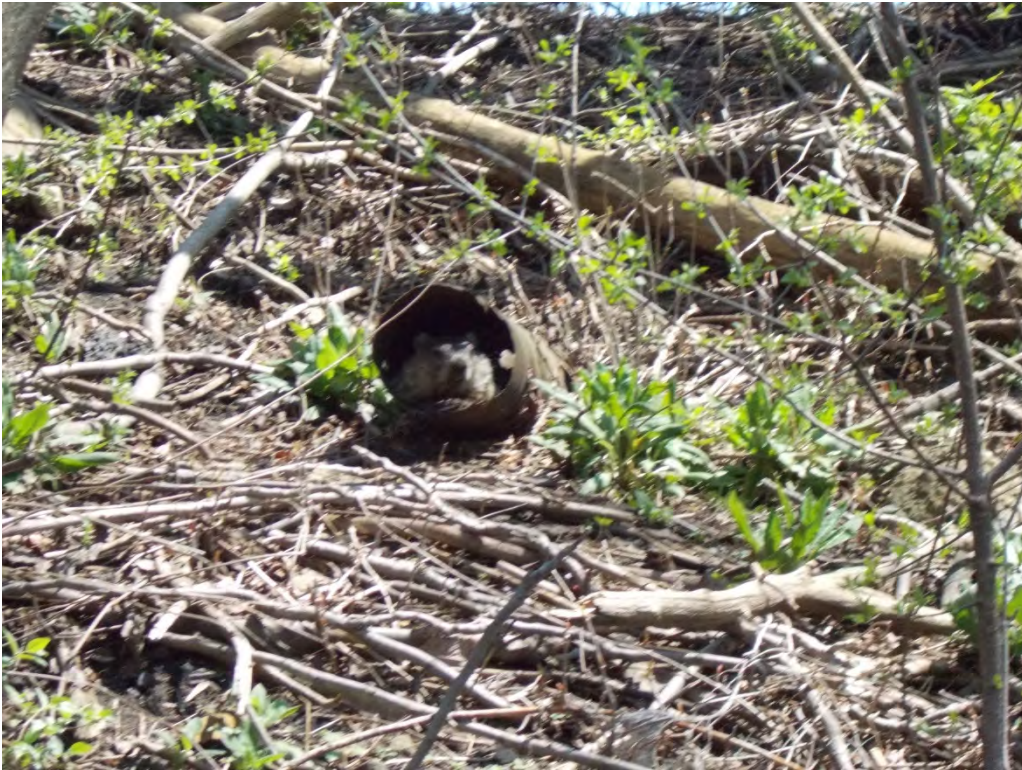
- The pipe is severely deteriorated. The end of the pipe has complete section loss around much of its circumference and there is a large hole in the north side 2' from the end.

View of the structure from the channel

- It is likely that the pipe can be removed or cut off at grade and abandoned if it conflicts with sediment removal operations.

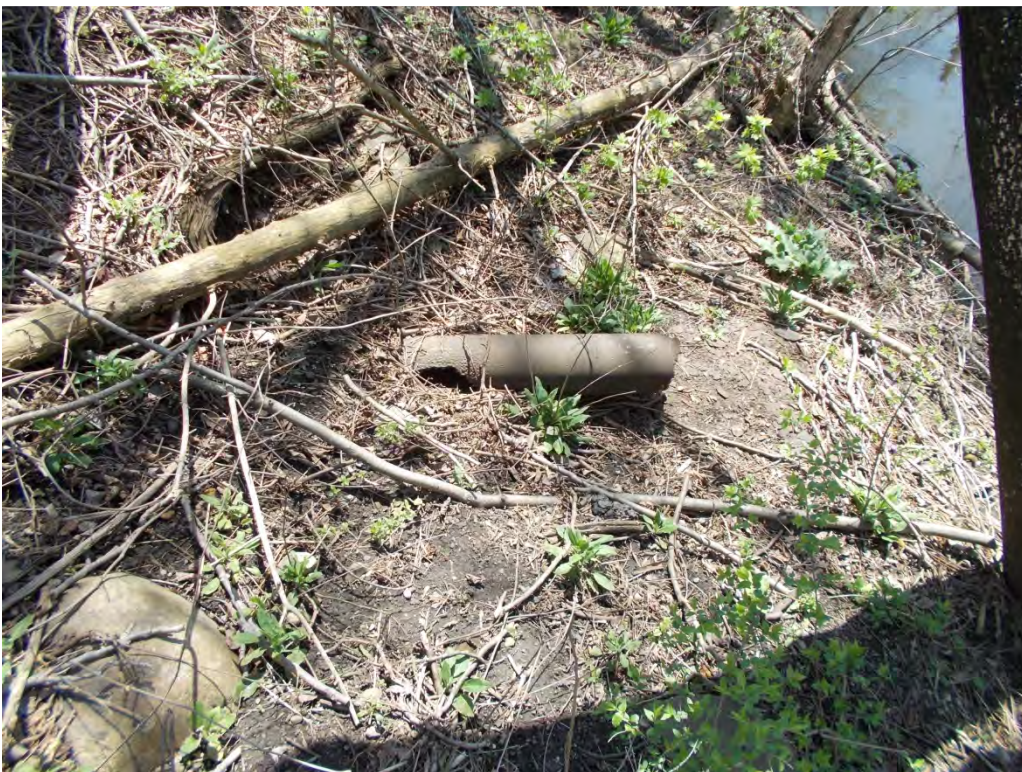
View of the structure looking south, showing large hole in north side

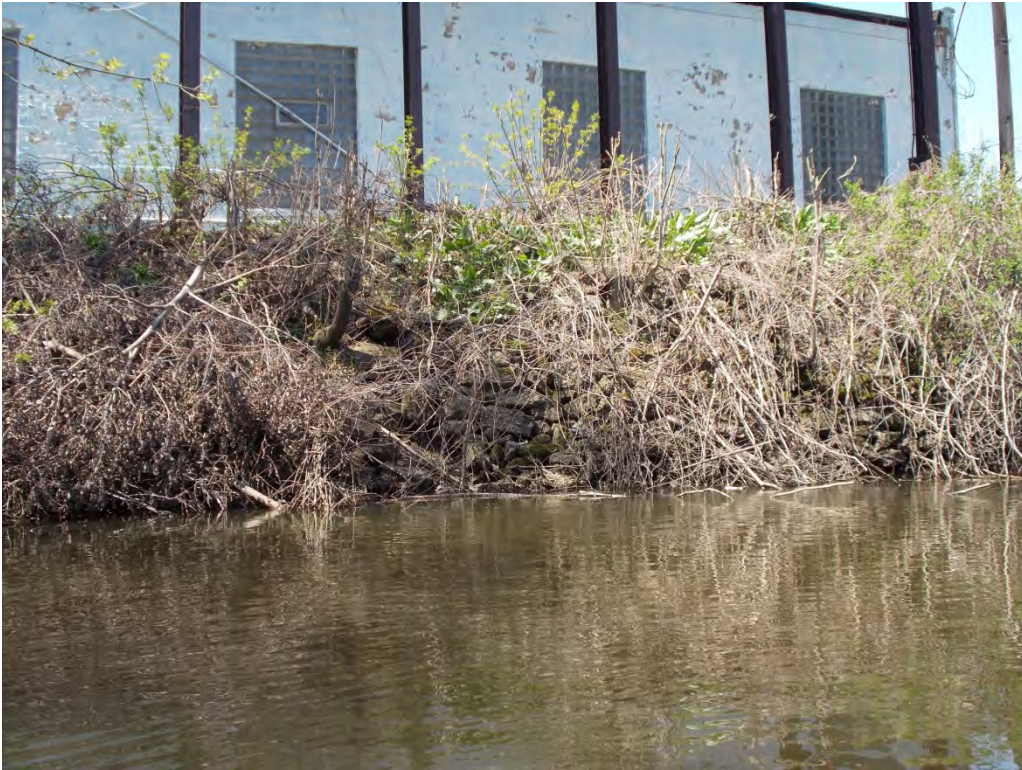
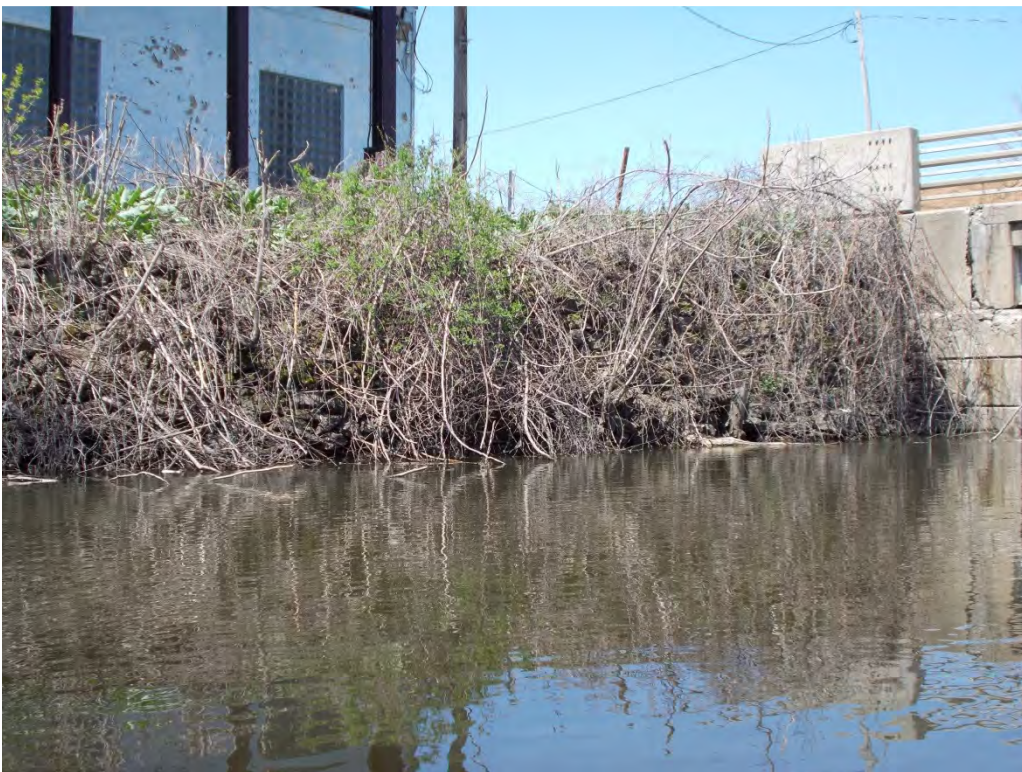
- The wall is overgrown with brush.
- A number of dislocated blocks were noted.

View of structure from the channel

View of the structure from the channel

- Sheet pile cofferdams should be located a minimum of 3-4 feet from the toe of the structure. Sand bag cofferdams could be placed closer to the structure.

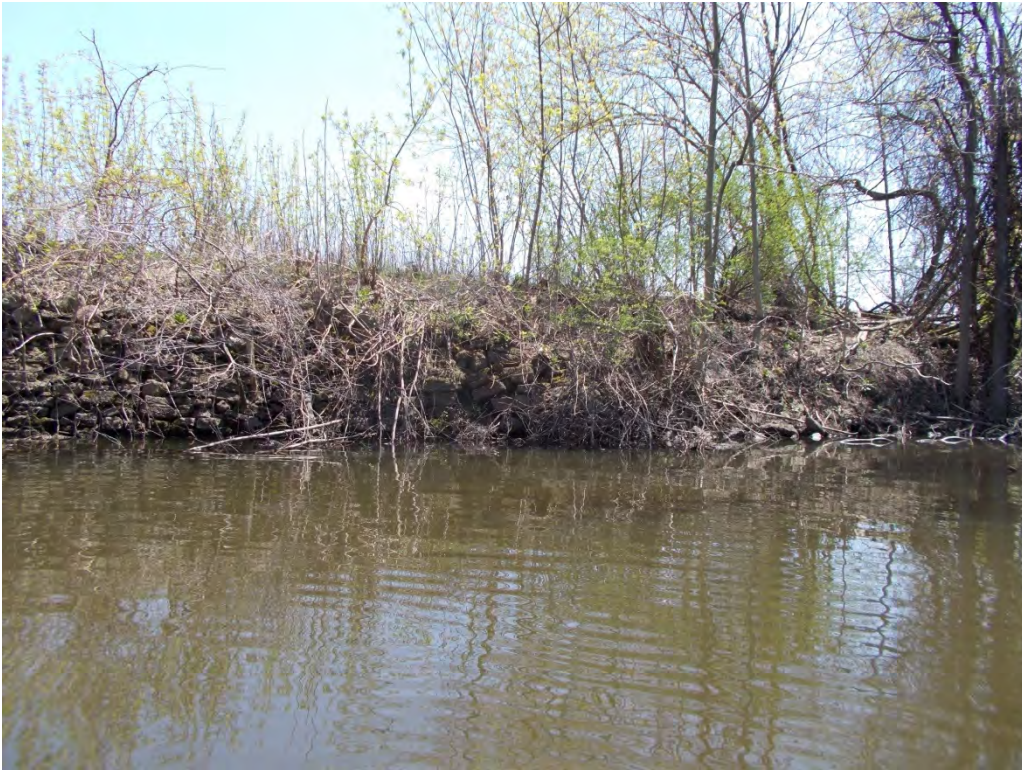
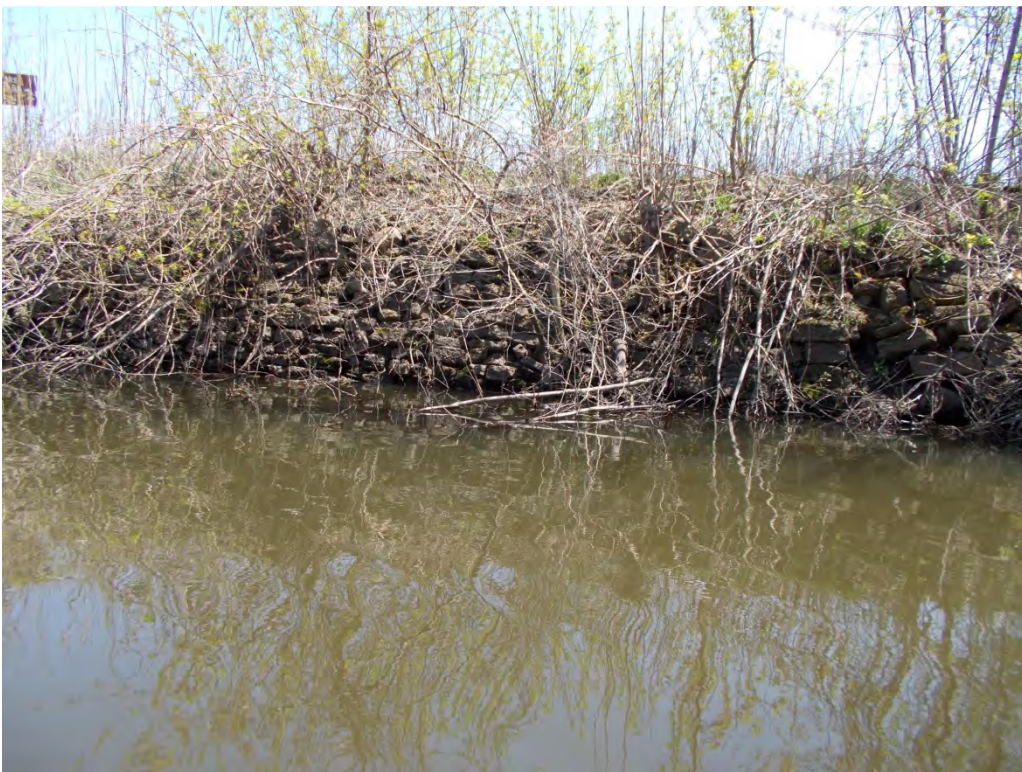
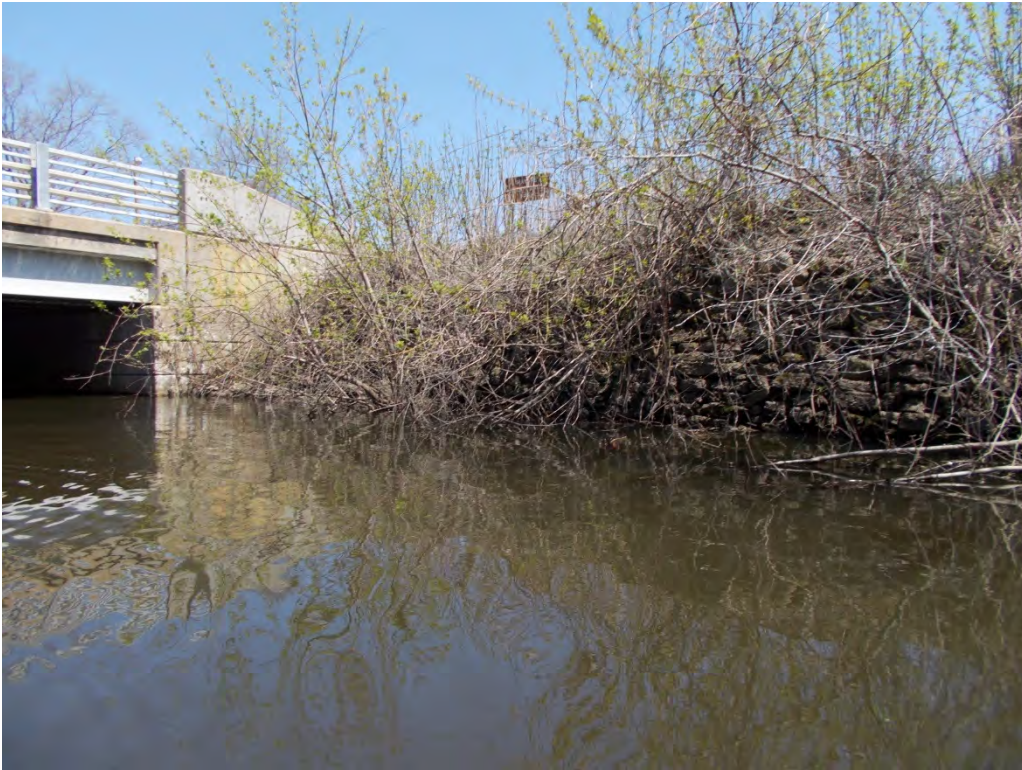
- The wall is overgrown with brush.
- A number of dislocated blocks were noted.

View of structure from the channel

View of the structure from the channel

- Sheet pile cofferdams should be located a minimum of 3-4 feet from the toe of the structure. Sand bag cofferdams could be placed closer to the structure.

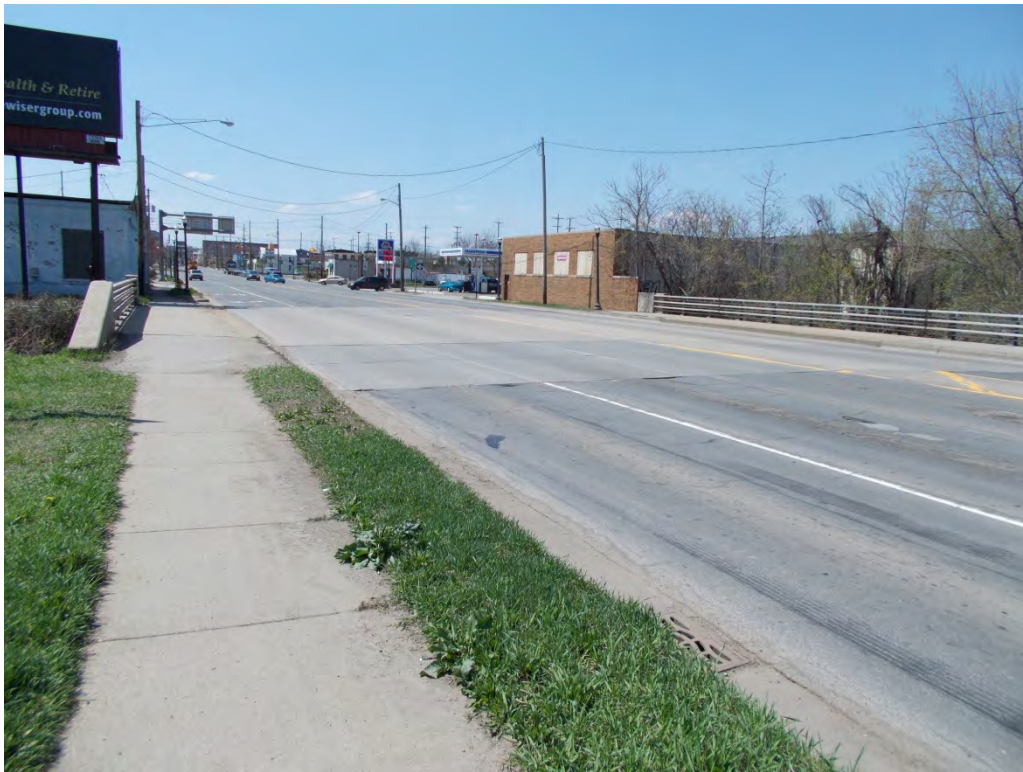
View of structure from the southeast approach area

- The 12" storm sewer outlet in the southeast should be isolated with a cofferdam during sediment removal. A minimum clearance of 2-3' is recommended for the cofferdam. Other outlets encountered should be protected similarly.
- Because the bridge is supported on spread footings, which are more susceptible to vibration and settlement than structures on deep foundations, a minimum clearance of 6-8' is recommended for sheet pile cofferdams near the structure.
- Utilize Miss Dig Flagging to confirm the location of gas, electric, force main and water main in the area of the structure prior to installing any cofferdam structures. Maintain a minimum of 4-6 feet clearance with any sheet pile cofferdams or as directed by the utility.

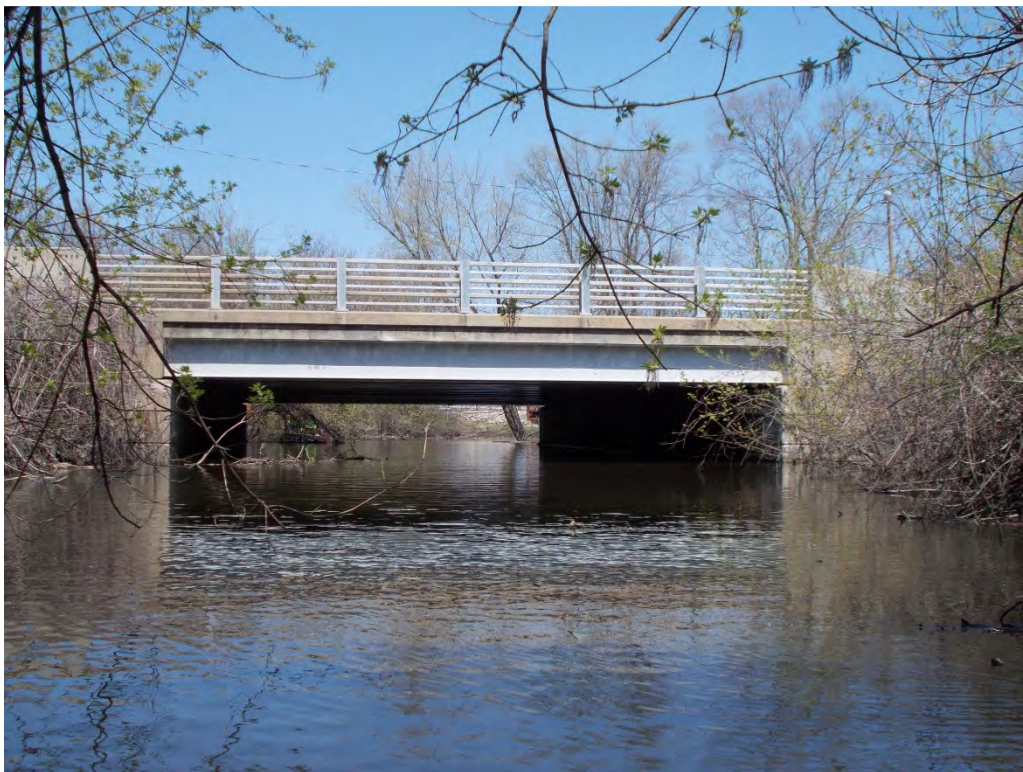
Elevation view of the structure

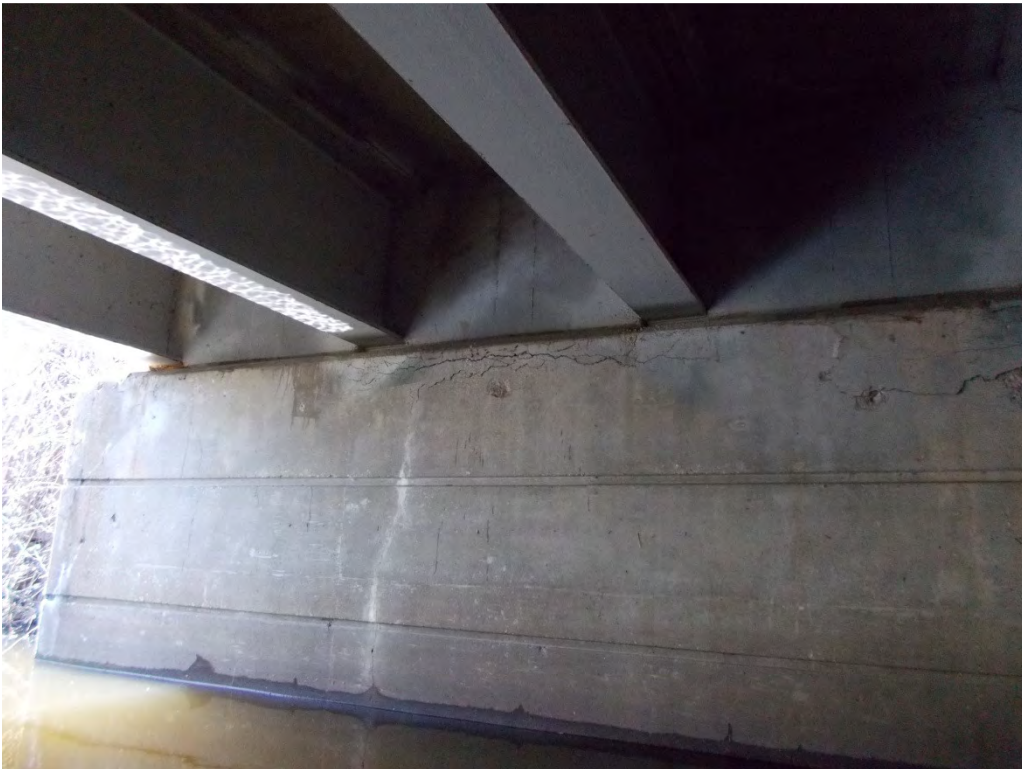
- Moderate slope/bank erosion was noted in all 4 quadrants, severe in the northwest.
- The abutments have minor to moderate vertical cracking scattered throughout. There is an isolated spall to steel beneath beam 4S on in the southwest. The top of abutment is cracked and delaminated between beams 1S and 5S in the southwest.

Cracking and delamination on top of abutment in southwest

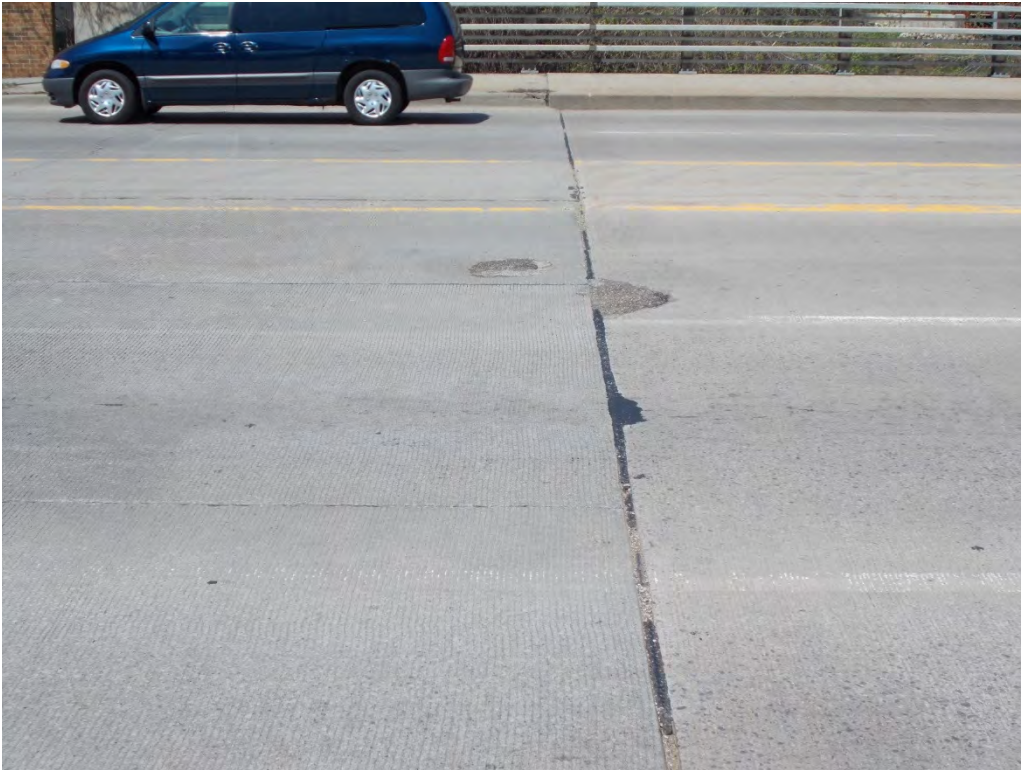
- The deck has an isolated area of spalling, approximately 12"x18" along the west reference line near centerline.
- There is a failed cable railing in the southwest.

Deck spalling along west reference line near centerline

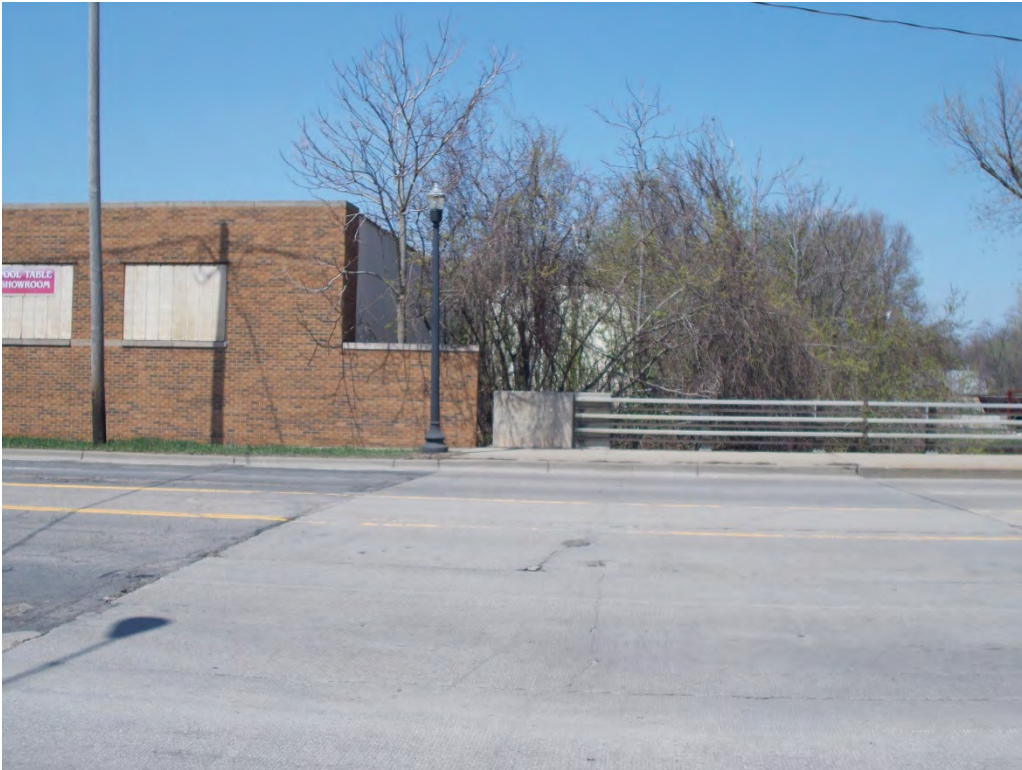
- The decorative street light in the northwest quadrant has sustained damage to its base.
- The asphalt pavement beyond the concrete approaches is severely deteriorated with significant cracking and spalling/cold patch.

View of decorative light in the northwest

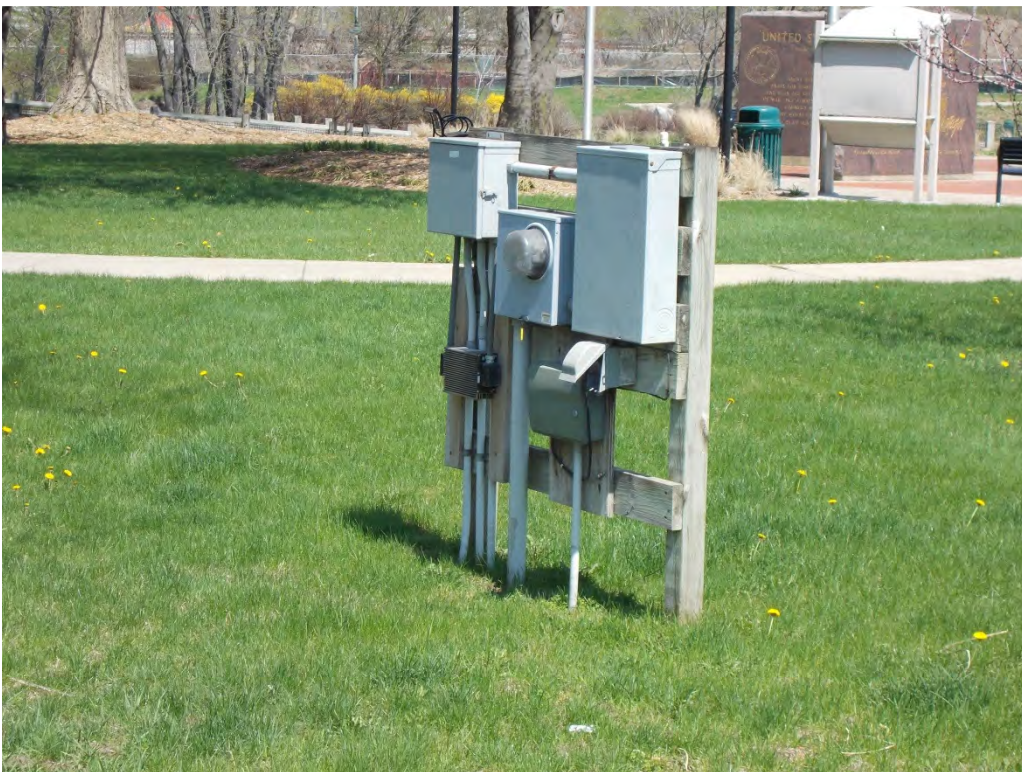
- Heavy brush growth was noted in all four quadrants.
- There is a service panel for the park in the northeast quadrant.

Service panel for park in the northeast

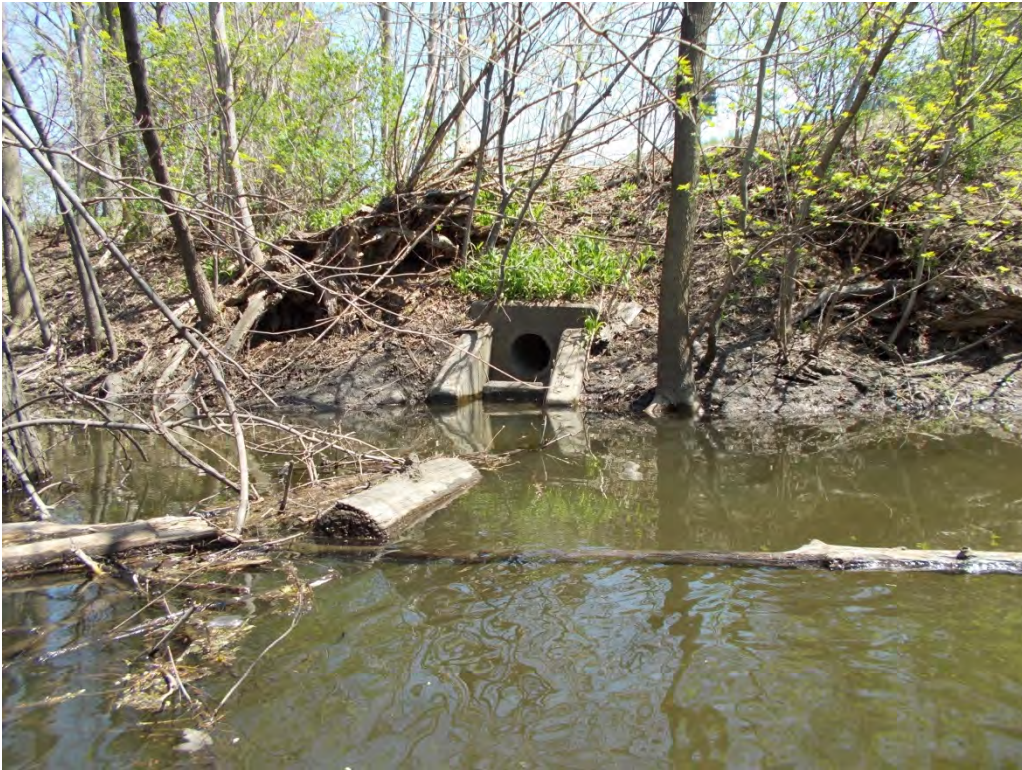
- The pipe appears to be in fair to good condition, with minor mortar cracking at the end.
- The headwall appears to be in good condition. No undermining was detected.

View of structure from the channel

- The outlet should be isolated with a cofferdam during sediment removal. A minimum clearance of 2-3' is recommended for the cofferdam.

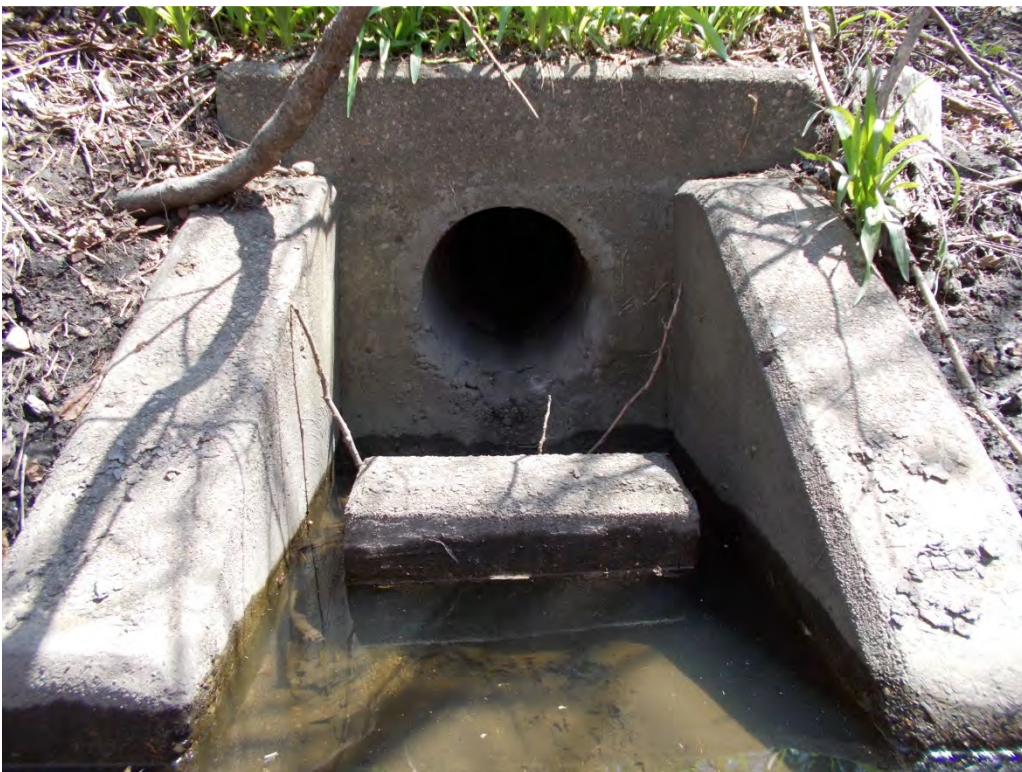
Close-up view of the structure
